# RESIDENTIAL TRUE OAK® CORRUGATE SOFFIT FLASHING FOR HORIZONTAL CORRUGATED.

DETAIL NO. RTCW026A  
DATE DRAWN 30/01/14  
FILE REFERENCE RI-RTCW026A.DWG

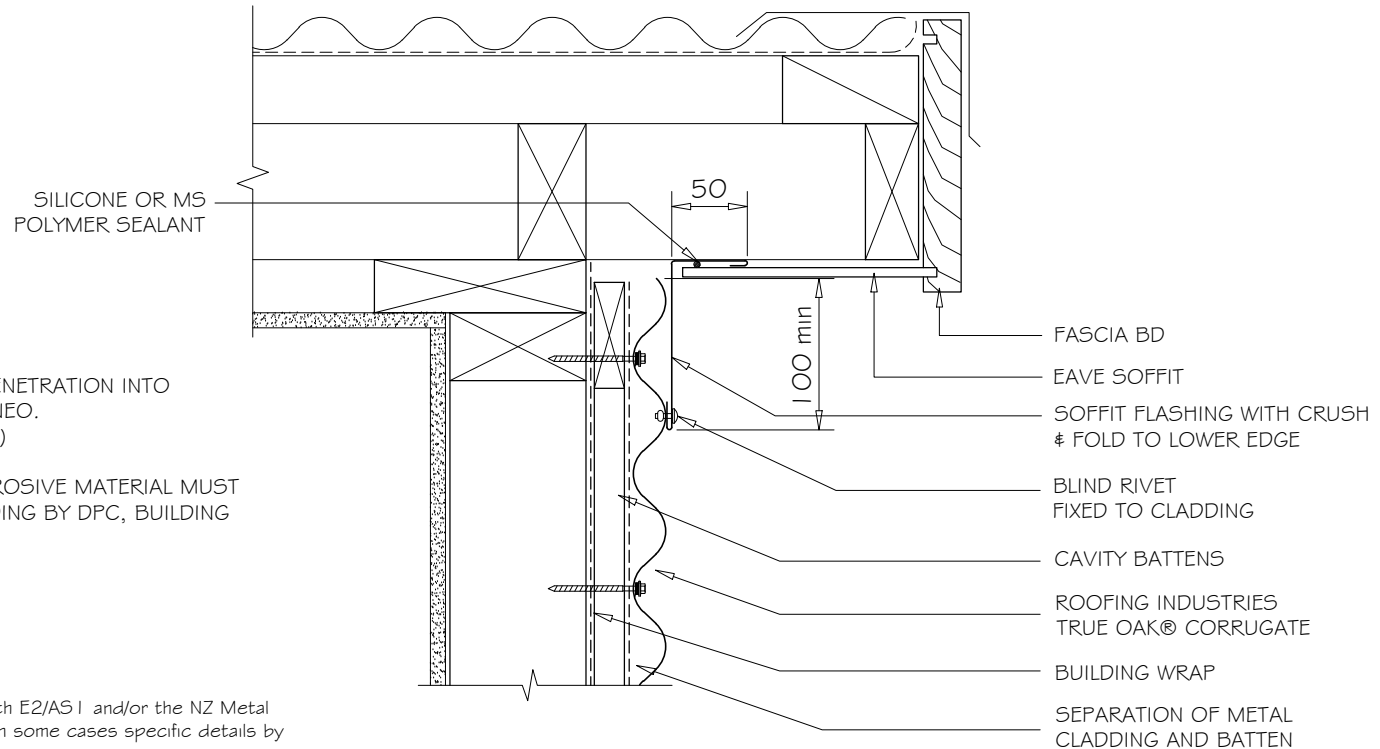
## SOFFIT FLASHING HORIZONTAL TRUE OAK® CORRUGATED

1. MINIMUM 12 GAUGE WITH 30mm PENETRATION INTO FRAMING TIMBER TEKSCREW WITH NEO. (USE STEELTEK FOR STEEL FRAMING)
2. CAVITY BATTENS CONTAINING CORROSIVE MATERIAL MUST BE SEPARATED FROM METAL CLADDING BY DPC, BUILDING WRAP, PVC OR PAINTING.
